SAFETY GLAZING MATERIAL TEST REPORT

LUOYANG LANDGLASS TECHNOLOGY CO., LTD.
Guangjian Building, No. 12
Wangcheng Road, Luoyang 471000 China

Report No.: G6138.01-119-37-R1
Test Date: 12/12/16
Report Date: 01/04/17
Revision 1: 04/19/17

Testing in accordance with ANSI Z97.1-2015 & CPSC 16 CFR 1201 (1977)

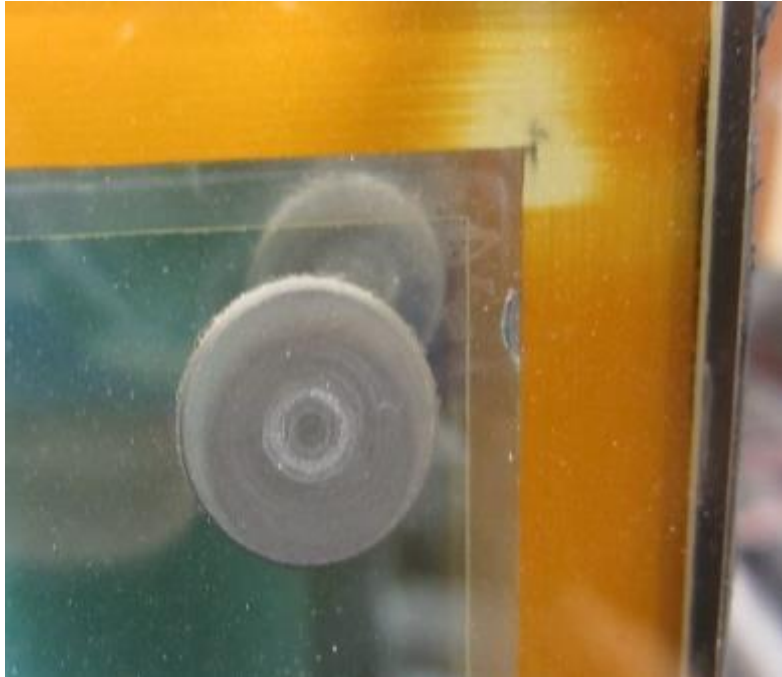
Photo No. 1a
One of three corners - Interior

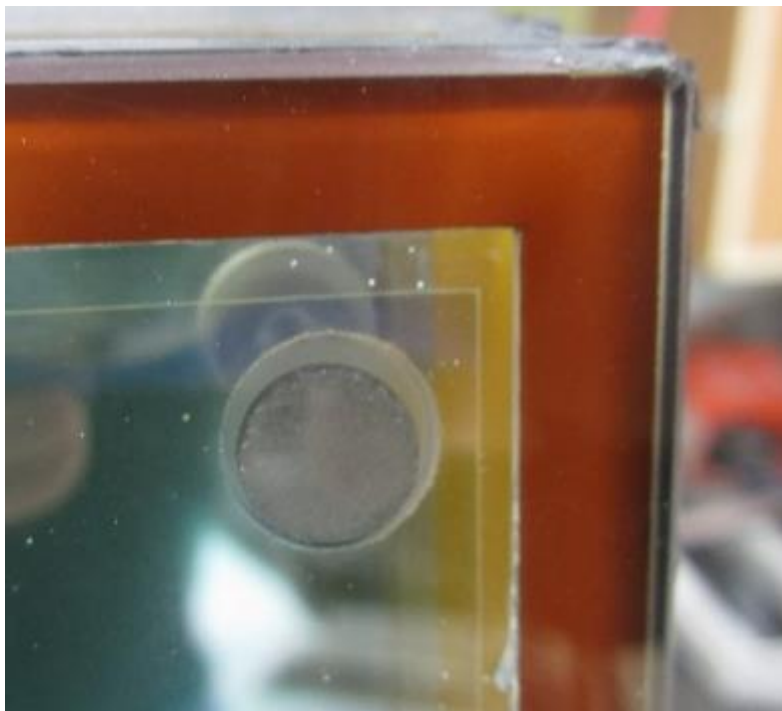
Photo No. 1b
One of three corners - Exterior

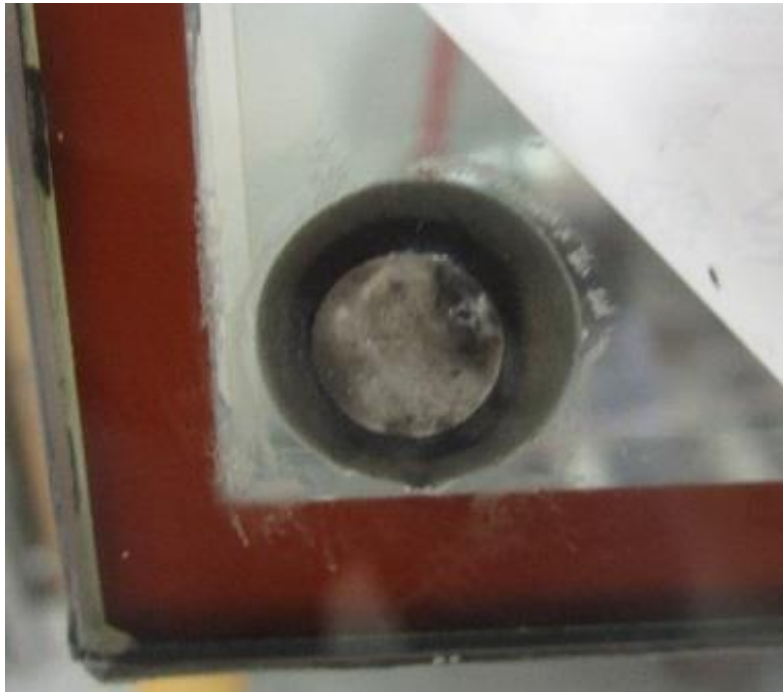
Photo No. 2a
Vacuum port - Interior

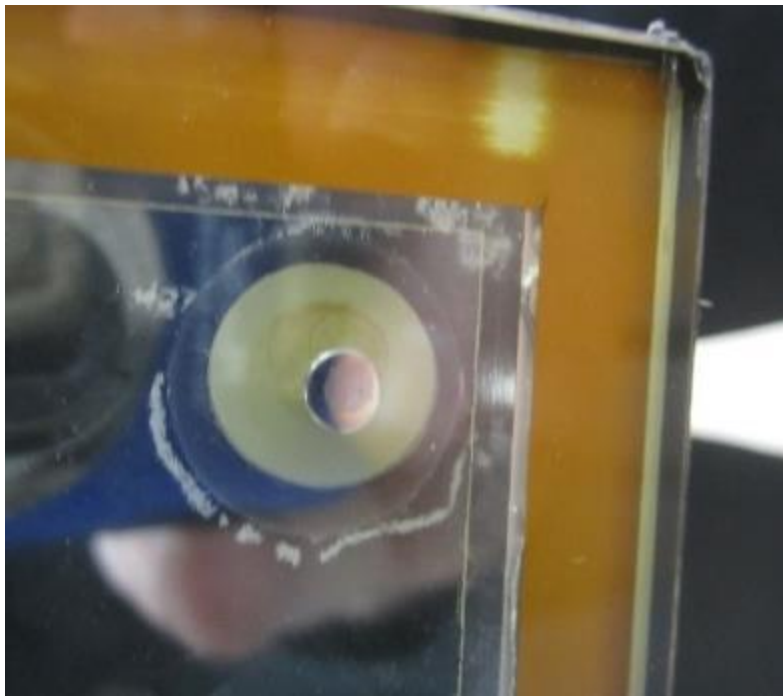
Photo No. 2b
Vacuum port - Exterior

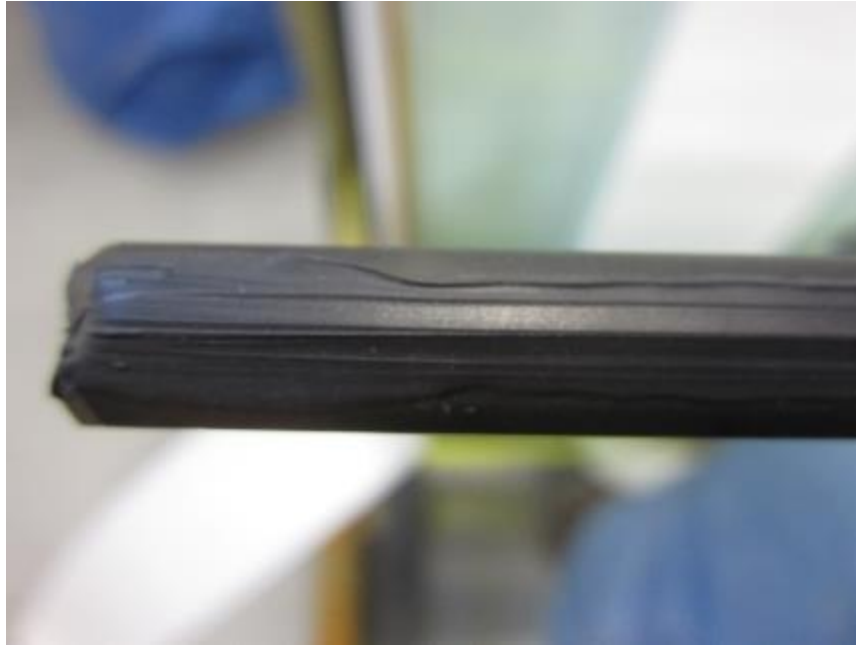
Photo No. 3
Perimeter Sealant

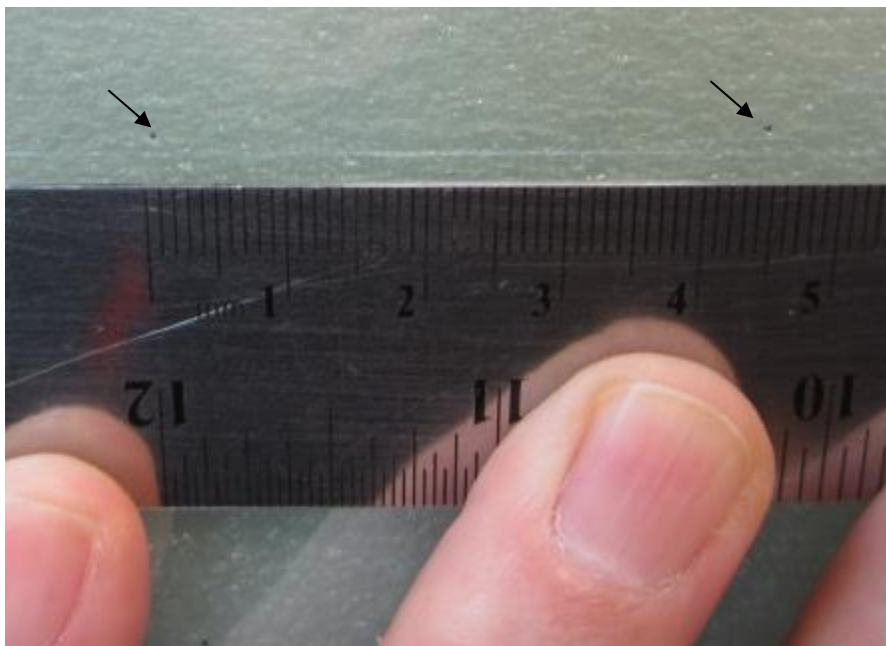
Photo No. 4
Pillar Spacing
